LECTURE HALL THERMAL COMFORT

UNIVERSITY OF OREGON: EUGENE
ANDY MCKELVEY

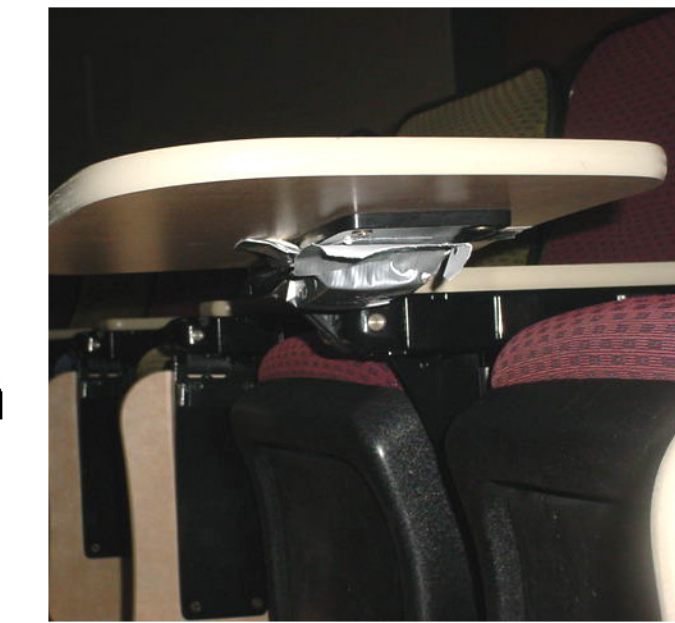
Right: Fig. 3. Typical sensor placement.

To test my hypotheses, I placed five HOBO microdataloggers in the positions shown in Figure 3 and one on the north side of the building adjacent to the lecture hall. These dataloggers recorded relative humidity and dry-bulb temperature in 5 second increments from 8:25am to 8:45pm during test days. I placed the sensors only on Wednesdays in order to get comparable data between days with identical class schedules.

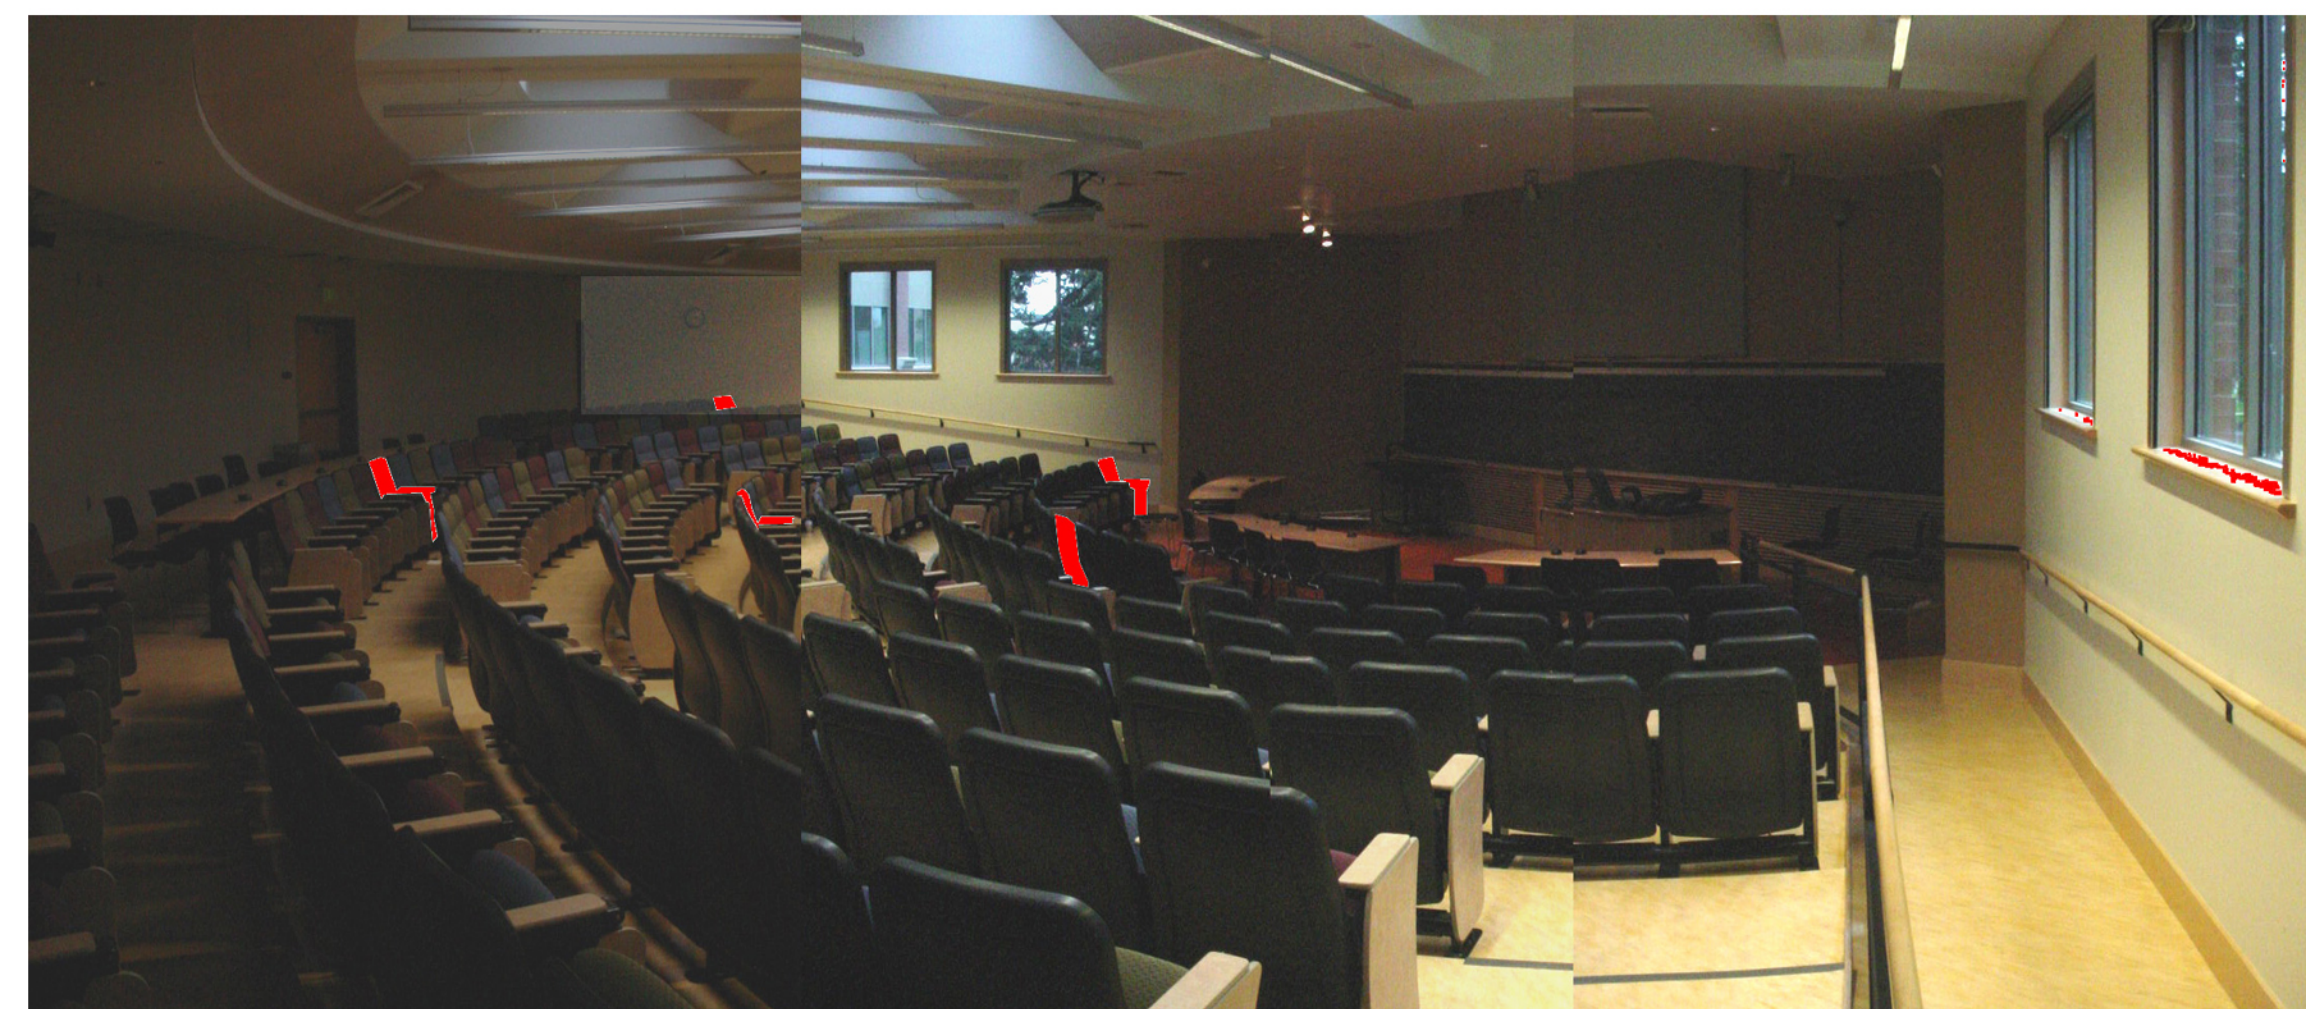
Right: Fig. 4 with sensor location key

Results of the March 2 tests are displayed in Figure 4 with degrees Fahrenheit as the range and time of day from 8:25am to 8:45pm as the domain. In addition, a flat line is included for each sensor, indicating the average temperature read by the sensor throughout the testing period. Times of day when the room is occupied are shaded regions on the graphs.

There are three morning classes (the third following immediately after the second), two afternoon classes, and one evening class. Indoor humidity remained between 30 and 40% during the test period and is not shown on the graph.

The coldest position / time during the occupied March 2 test period is the end of the last class of the day in the middle of the front of the room and the warmest position /time during the occupied March 2 test period is the end of the third class in the middle-back of the room. In both cases, the humidity / temperature readings are within the ASHRAE 55-2004 comfort zone [see Figure 5]. This proves my hypotheses correct; 282 Lillis is within the thermal comfort zone throughout the day and throughout the room.
