Monitoring Restoration of the South Fork of the Crooked River Using Stream Profiles

Henry DeGrazia, Bio 410 Summer 2009

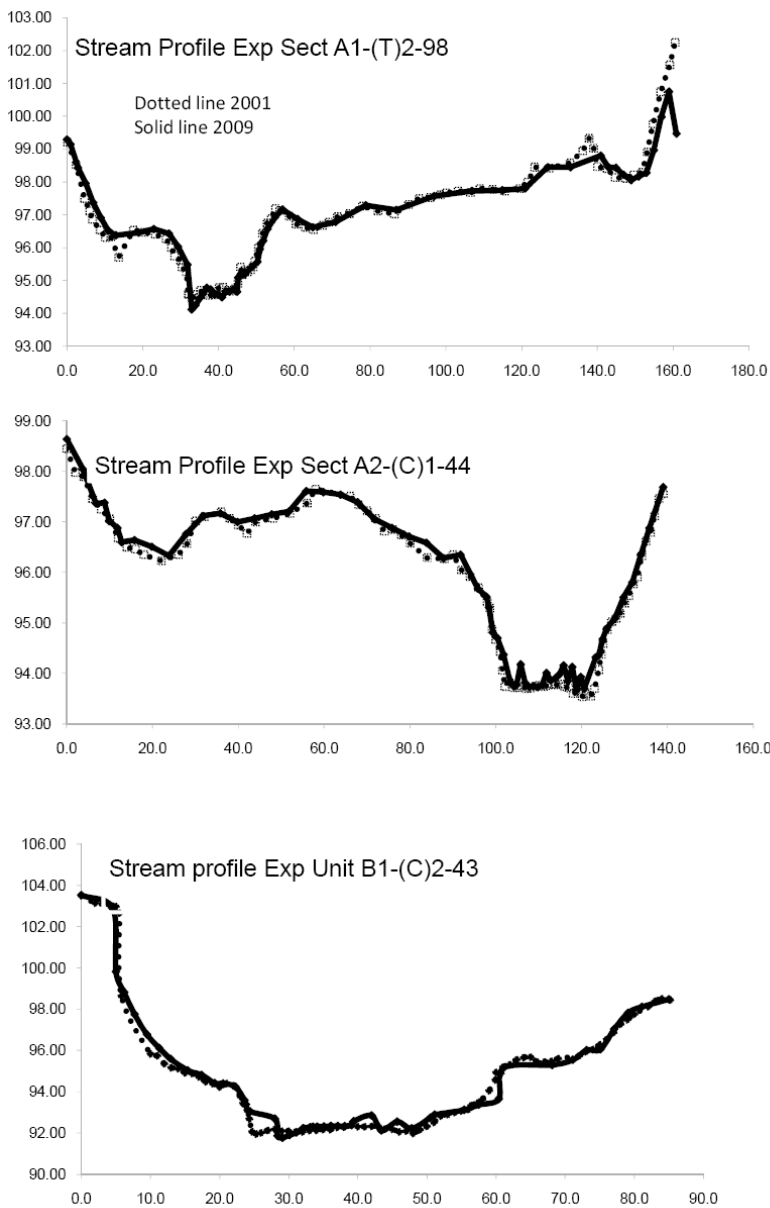
Figure 1. Stream profiles compared at one limited rotation grazing treatment (T, top) and two treatments where cattle have been fully excluded for eight years (C, panels 2 & 3). There has been remarkably little change in stream profile at all three locations since cattle were excluded. This may indicate that limited grazing rotations prior to full cattle exclusion were successful at limiting riparian damage, or it may indicate that barrier fencing has not been effective at excluding cattle since 2001.

Data were analyzed using Open Office then converted to an Excel format. Both versions of the spreadsheet containing raw data are available by contacting Matt Orr. Stream profiles and pebble counts have remained remarkably consistent from 2001 until 2009 (Figures 1 & 2; see in text after References section). Stream velocities were 2.04 ft/sec at A1, 1.53 ft/sec at A2, and 1.68 ft/sec at B1. Bank angle measurements from all sites recorded to date are below (Table 1; in text after References). We do not have BLM data on stream velocities and bank angles for comparison to 2009 measurements.

While the data provide some hints of changes (a slight narrowing of the left bank in experimental unit B1 and a slight deepening of the channel along the left bank in experimental unit A1), the differences are too small and the data sample too limited to draw any clear conclusions at this point. Further data will be necessary to determine whether the channel is actually narrowing and deepening as expected. There may be a slight shift towards larger pebble sizes at the sites, which would also be indicative of the river returning towards a healthier state with lower sediment levels in the water. At this point, however, a lack of change seems to be the strongest pattern at these three sites in the eight years since treatments were implemented. There are three possible explanations for the lack of changes seen here. First, at some locations it may take as long as 20 to 30 years to see significant riparian improvement once cattle are removed (Wyman 2006). Part of what may cause a delay, at least in the case of the present study, is that forage grasses now form a large (and in the case of transect B1, dominant) component of the streamside community. Such forage grasses are not well-suited to

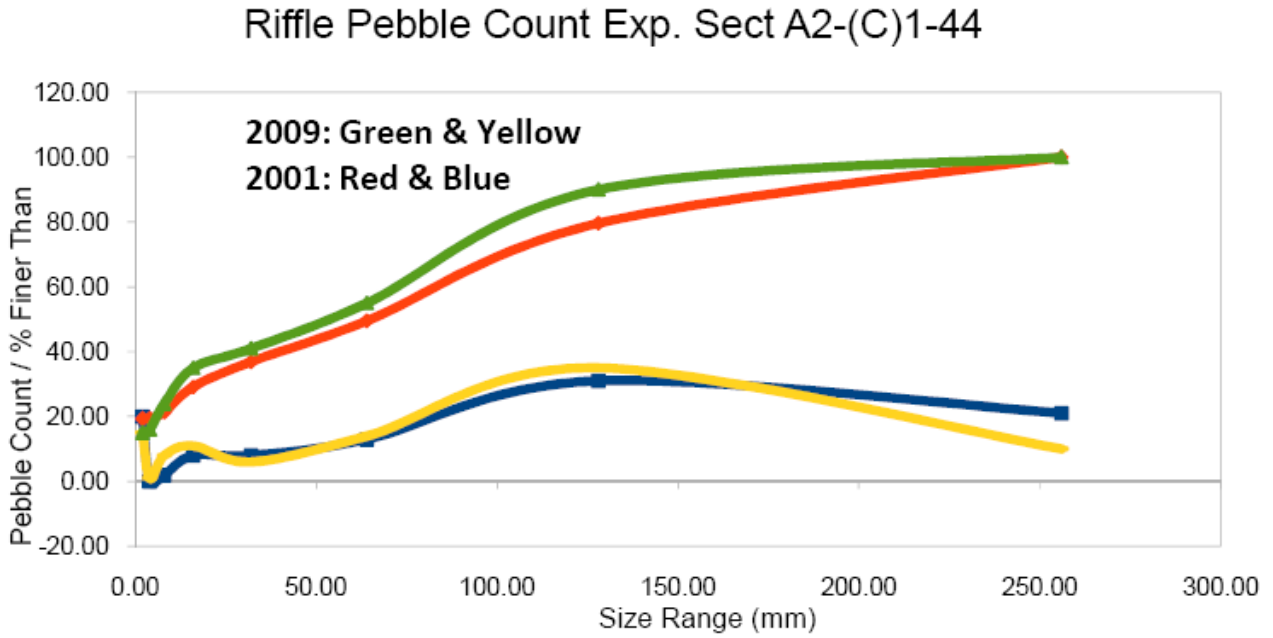
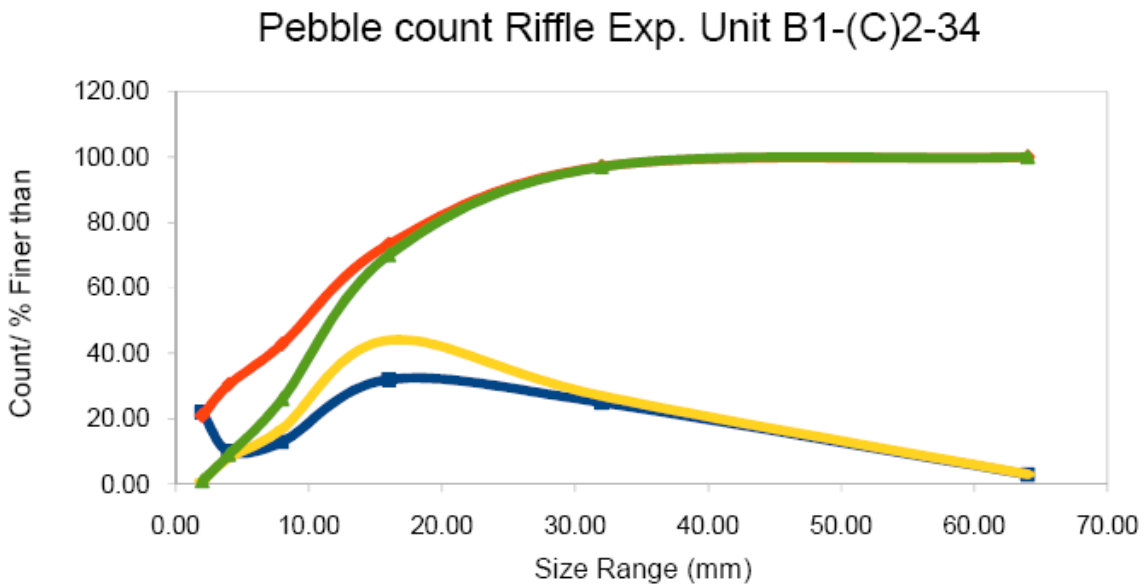
Figure 2. Pebble counts. Data from 2009 are green and yellow lines; data from 2001 are red and blue lines. Comparison for site A-1 awaits 2001 data from the BLM.
