THERE'S MOLD IN MY BATHROOM!

A STUDY OF RH, TEMPERATURE, AND THE GROWING CONDITIONS OF MOLD

Sylvan Cambier, Brita Carlson, Monica Klyce & Josh Kolberg
University of Oregon
Department of Architecture
Eugene, OR 97403
email: scambier@uoregon.edu, bcarlson@uoregon.edu,
mklyce@uoregon.edu, jkolberg@uoregon.edu

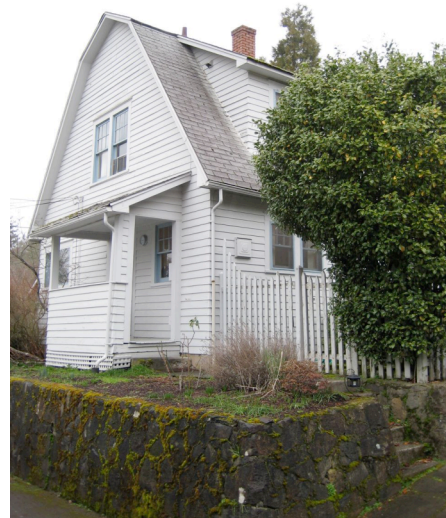
Fig. 1: Brita's home in Eugene, OR

The house studied is an older rental home in Eugene, Oregon, (see Fig. 1) and is the current residence of one of the authors of this study, Brita Carlson. As is seemingly typical with older rental houses, there are heat and humidity issues. The occupants informed us that the ceiling in the bathroom is a constant breeding ground for mold and needs to be cleaned regularly. We quickly realized this could be a good case study that would force us to look at a number of factors that might lead to this “moldy” environment.

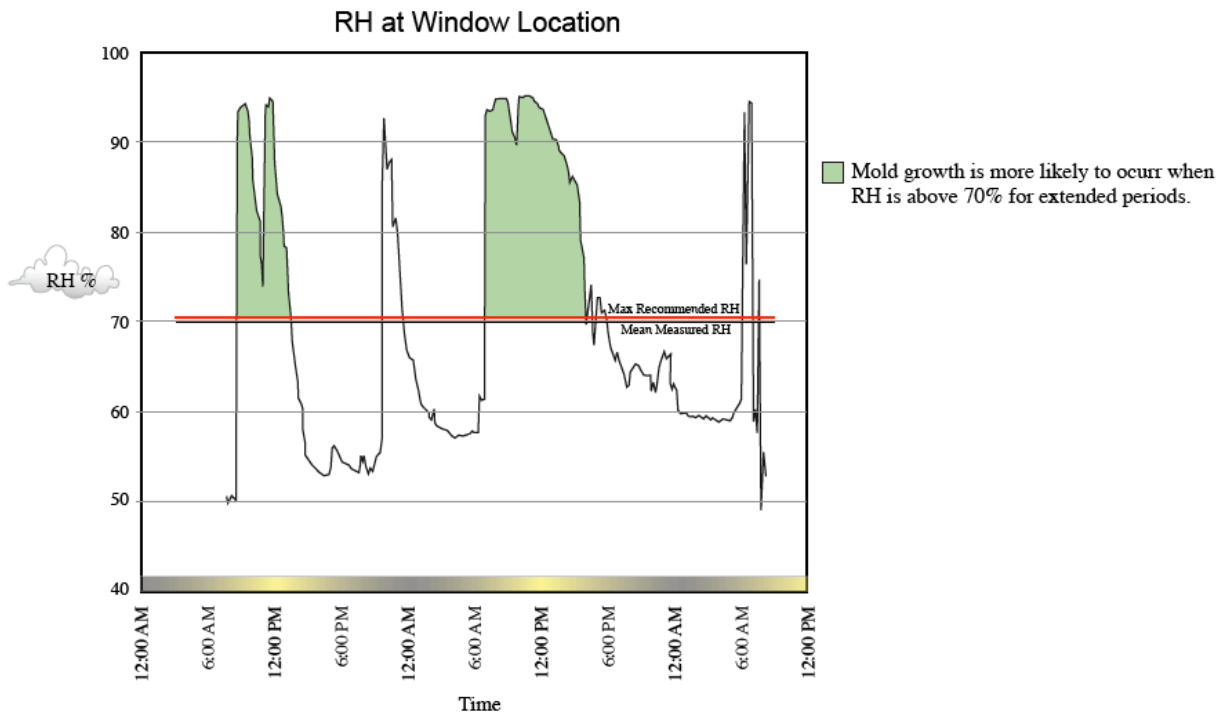
Fig. 3: RH over time from the window data logger

RH levels in Brita's bathroom did indeed exceed the 70% maximum for extended periods. The data logger near the window showed an average RH of just under 70%, with several large peaks approaching 95% RH (see Fig. 3). The data logger located at the wall had a slightly lower mean RH but still only 4% below the recommended maximum (see Fig. 4). Both data loggers recorded RH measurements that exceeded the 70% threshold for more than 12 hours in a given 24-hour period.

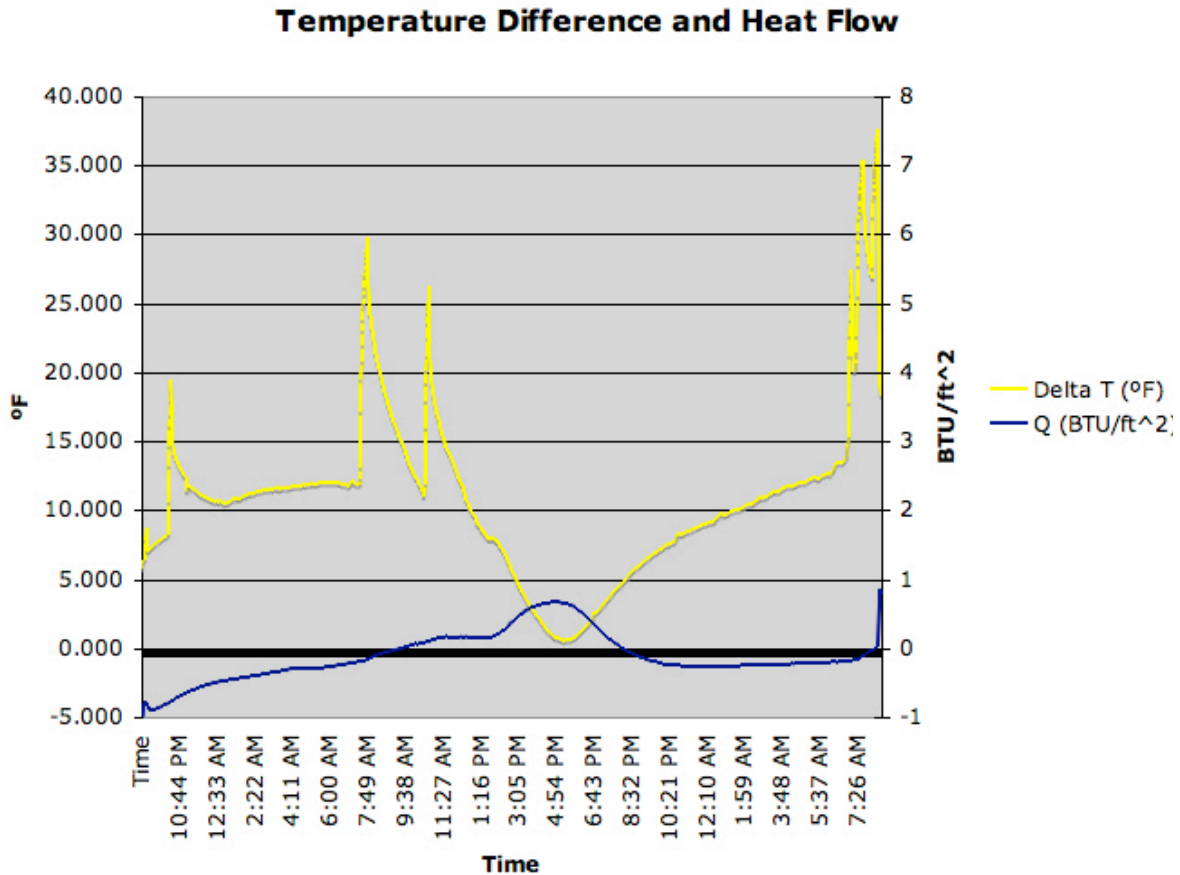
Fig. 5 – Temperature & Heat Flow over time

Measurements from the HFT (see Fig. 5) did not yield consistent values for the insulating properties of the bathroom ceiling. One possible explanation for the change in heat flow despite a consistently positive value for delta T is that the attic floor boards behaved more like isolated thermal mass than a thermally connected piece of the bathroom ceiling. Large gaps between boards in the attic allowed significant air flow around each board, creating heat exchange independent of heat flow through the ceiling. A better location for the HFT would be the interior surface of the bathroom ceiling. Because the measurements did not yield meaningful data for our purposes, we show it only as auxiliary data.

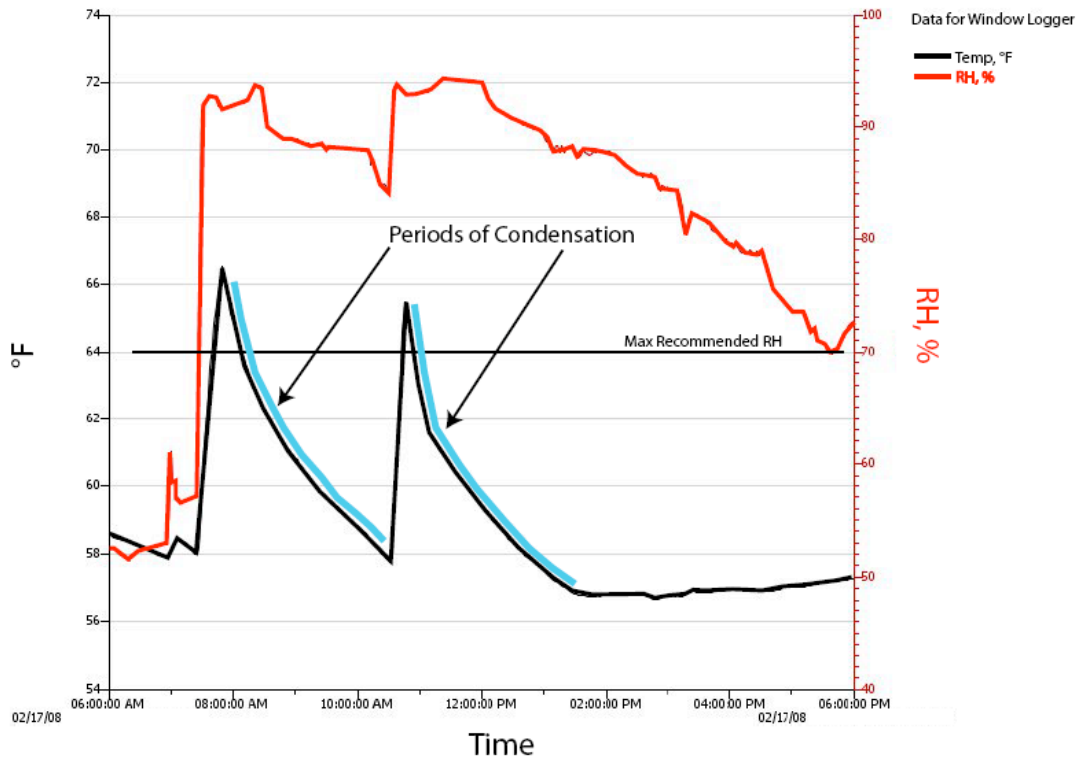
Fig. 6: Temperature & RH plotted from 6:00 AM on 02.17 thru 6:00 PM that same day

It is clear that the spikes in temperature and RH in these graphs correspond to showers. When the data is narrowed to look at a smaller time frame one can see the dramatic changes in both RH and temperature due to showers in this space (see Fig. 6 on following page).

At roughly 7:30 AM on Sunday the 17th of February both the temperature and RH are at acceptable levels. The temp in Brita's bathroom is a cool 58 degrees and the RH is an acceptable 53%. At this moment, the shower is turned on and a rapid change takes place for both temp and RH. During this shower the temp spikes up to 66.5 degrees and the RH skyrockets to over 90%. As the Healthy Housing book describes, these are conditions ripe for condensation (warm air that is super saturated with water vapor). But for condensation to occur, the air temperature must drop. By roughly 10:45 AM the air temperature in Brita's bathroom has reset to a cool level of 57.7 degrees. The large amount of water vapor then condenses on bathroom surfaces, especially the ceiling over the shower. After that first shower early in the morning, and aided by a second shower later, the RH does not return below the 70% mark till almost 6:00 PM that night.

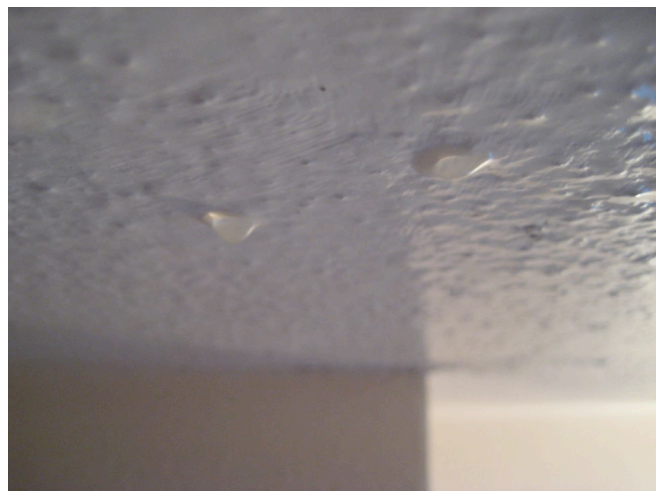
Fig. 7: Condensation on the bathroom ceiling

Per the Healthy Housing book, condensation is considered serious when it is found, "on the surface of walls, floors, and ceilings". This is exactly the case in Brita's bathroom. Direct observation revealed condensation on the bathroom ceiling and on the window, among other locations (see Fig. 7 on this page and Fig. 8 on the following page).

It could be helpful to replace the current fan with one that has a larger capacity and can be operated independent of the light. After showering, the fan could be left on after the occupant leaves to aid in reducing RH.

Maintaining a consistently higher temperature would help prevent condensation. Not knowing the effectiveness of the electric baseboard heater, it is difficult to say whether it could help maintain a more steady temperature if it were left on. One possible step towards reducing condensation would be to leave the heater on for longer periods. The potential drawback of this approach is the additional expense incurred via the electric bill.

Improving the insulation in this bathroom would help to moderate temperature swings, and thus help the condensation problem.

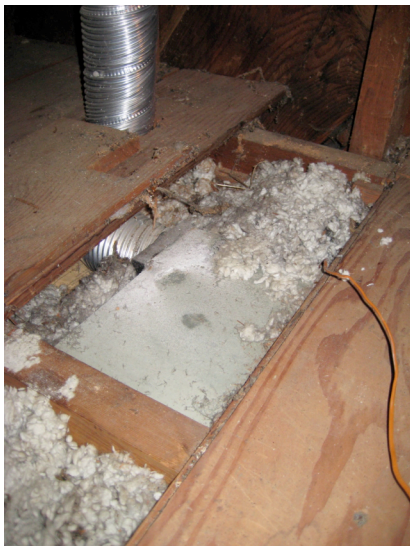
Fig. 9: Exposed insulation in the attic, showing some degradation

Another negative effect of RH and condensation is damage and erosion of the building materials themselves. The conditions in Brita's bathroom are ideal for plaster damage and rotting of woodwork. This could be a possible reason for the degraded quality of the insulation in the ceiling above the bathroom (see Fig. 9).

This is an old home and is not well insulated. There is no insulation in the roof, including the part that forms the ceiling over the shower. The insulation that is in the ceiling of the bathroom is old and thin. It is fair to assume the insulation in the exterior wall is weak as well.
