HOT LUNCH

A Post Occupancy Study of the Food For Lane County Building

Tobin Newburgh, Michael Ober
University of Oregon
Department of Architecture
Eugene, OR 97403

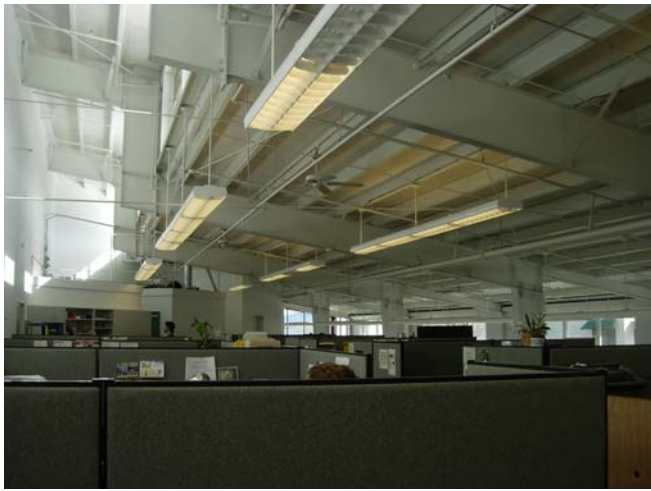
Fig. 2: Mezzanine office space with clerestory above.

The building's numerous energy-saving systems made it an attractive prospect for a case study. We simply had to determine exactly which system to examine. The answer came immediately after our arrival at the building, during a discussion with the building's operations manager, Ron Detwiler. Ron informed us that the office space on the mezzanine level was uncomfortably hot on sunny days regardless of the time of year. In fact, during the summer employees on the mezzanine routinely finish their workday at 2 o'clock, just before the heat grows to an unbearable level. After investigating other aspects of the building, such as the passive cooling in the warehouse, daylighting use, shading device performance and thermal mass, we concluded that studying the overheated mezzanine would offer the most design lessons. The persistent excess heat on the mezzanine level was a particularly intriguing phenomenon, considering that the building was painstakingly designed to avoid such thermal variations.

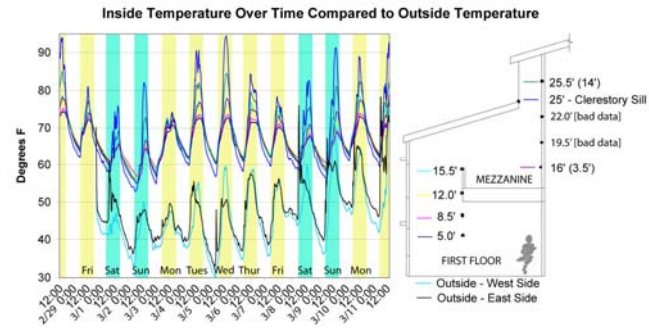
Fig. 3: Graph showing dry-bulb temperature at a series of vertical spaces inside the building compared with outside temperature on the west and east sides of the building. Color bars show approximate daylight times. Blue bars show weekend times when the building is unconditioned.

Fig. 3 shows the dry-bulb temperature at all of the other locations. Peak and low temperatures of the interior measurements line up exactly with those of the outside measurements, in other words, there is no thermal lag. Although the peak temperatures for the locations nearest the ground floor remain relatively consistent, the temperatures for the mezzanine level and clerestory vary dramatically. On March 4th, 5th and 9th a considerable amount of thermal stratification can be observed in Fig. 3. Additionally, first floor temperatures are much cooler than normal over the weekend when the building is not conditioned, while clerestory temperatures are still volatile. As expected, days with the highest temperatures tend, also, to have the lowest temperatures.

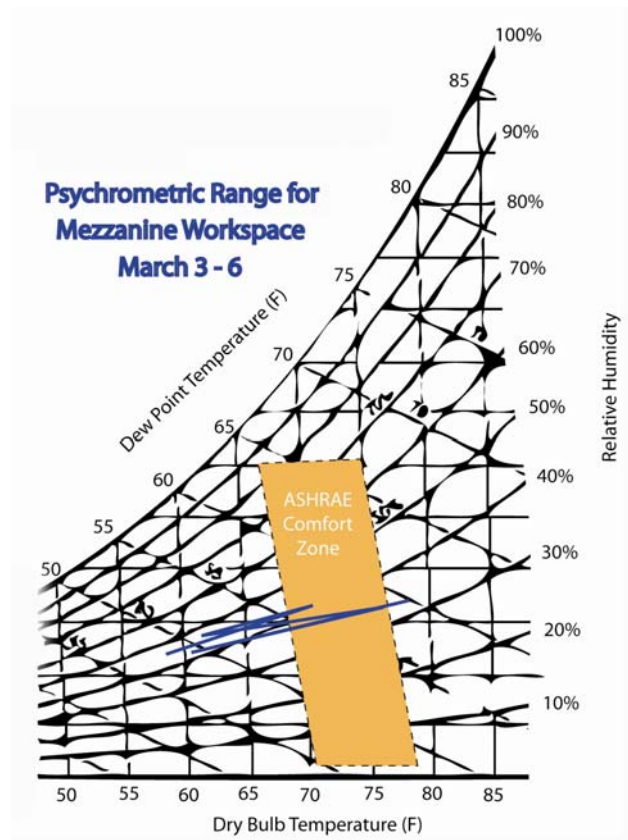
The period of Monday, March 3rd through Thursday, March 6th was selected for further analysis because it had two of the warmest and two of the coolest days in the data set and represents the general trends of all of the days observed. The range of relative humidity and dry-bulb temperature are plotted on the psychrometric chart in Fig. 4. Very little of the range actually fits in the human thermal comfort zone for one Clo as defined by ASHRAE Standard 55-2004. Interestingly, most of the time the building is cooler than deemed acceptable, however, this time is generally not during business hours. Of the four days plotted, only one

high temperature fit nicely within the comfort zone, one day's high is clearly above the zone, and the remaining two are on the border of too hot.

Fig. 4: Psychrometric chart showing relative humidity and temperature range at mezzanine level for March 3-6 referenced to ASHRAE thermal comfort zone.

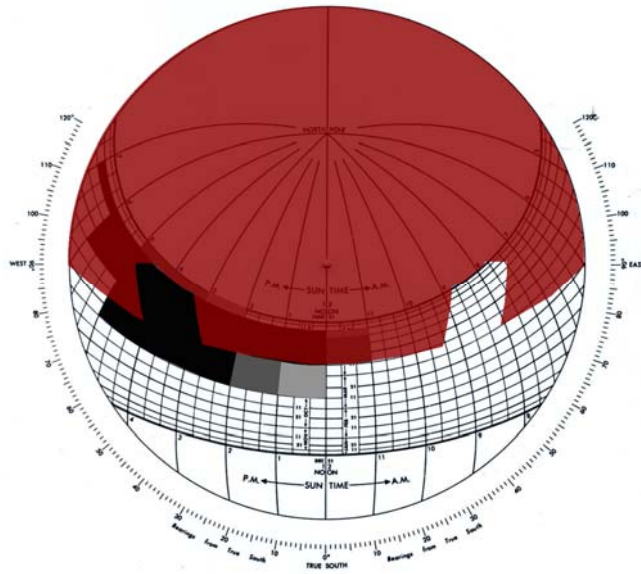
Fig. 7: Actual shading mask (red) of south facing shading devices overlaying ideal shading mask generated by SHADE2003.

Fig. 7 shows an ideal shading mask generated by the SHADE 2003 software using approximations of the space characteristics and occupancy use. A large number of variables go into the generation of the chart, so its accuracy is not particularly reliable. We set the cooling temperature to 72⁰F since the space is not actively cooled. The red overlay is the actual shading mask of the shading devices on the building. It can be seen that a great deal of the shading parameters are not covered by the solar shades. It is unlikely that this is a large contributing factor to the overheating of the space, but the effectiveness of the shading devices is a topic worth further investigation. Although blocking insolation outside of the building envelope is the most efficient means of controlling solar heat in a building, we recommend that the building occupants experiment with the use of internal shading devices to better mitigate glare and overheating.

Direct insolation, is another critical factor in analyzing thermal loads of a building. We were concerned that there may be too much south-facing glazing on the building, so we calculated the glazing the floor area ratio. The Food For Lane County building's glazing to floor area ratio is 11.73%, just below the 12-24% recommended in MEEB, so we concluded that this is not a significant factor in the overheating of the space. If, however, this glazing is unshaded at critical times, it could be problematic.
