# Will the Real R-value Please Stand Up

This study describes an approach to determine actual R-values in existing wood framed wall construction as compared to component calculated and prescribed R-values. The study examined a recently remodeled 1913 residence in Portland, Oregon. Four exterior framed wall areas, at various locations, were examined and tested to determine their actual R-values. The results and analysis confirmed that the wall assemblies thermally underperformed as compared to the Oregon Dwelling Specialty Code and energy standard requirements. The study provides useful information for designers and contractors when assessing actual thermal wall performance and considering future improvements for existing residential construction.

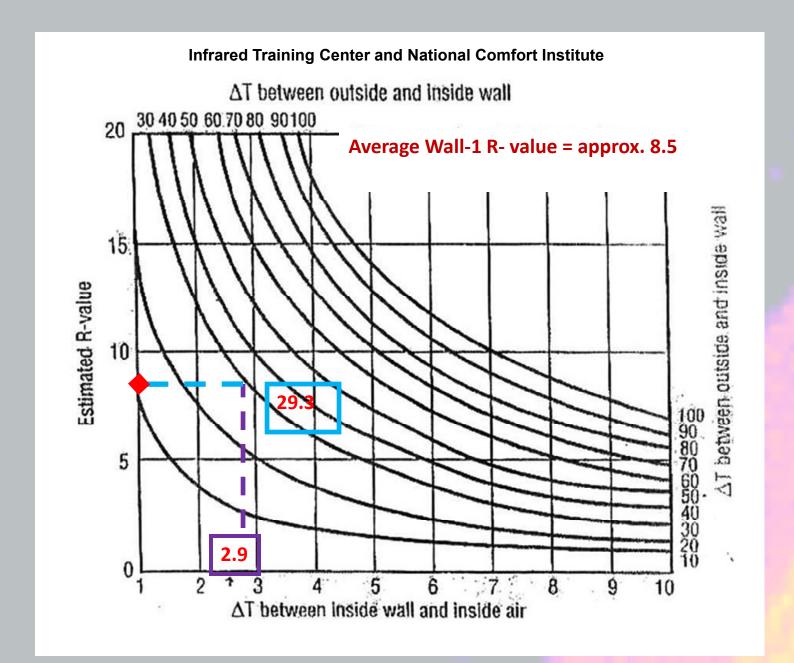
Wall-1	Wall -2	Wall -3	Wall -4
Exterior Wall - Inside Wall Surface				
Temperature	67.1	66.7	67.5	68.0
Exterior Wall - Exterior Surface				
Temperature	37.8	37.8	37.7	37.7
Interior Ambient Air Temperature	70.0	70.0	70.1	69.9
ΔT = Ambient Air - Inside Surface	2.9	3.3	2.6	1.9
ΔT = Inside Surface - Exterior Surface	29.3	28.9	29.8	30.3

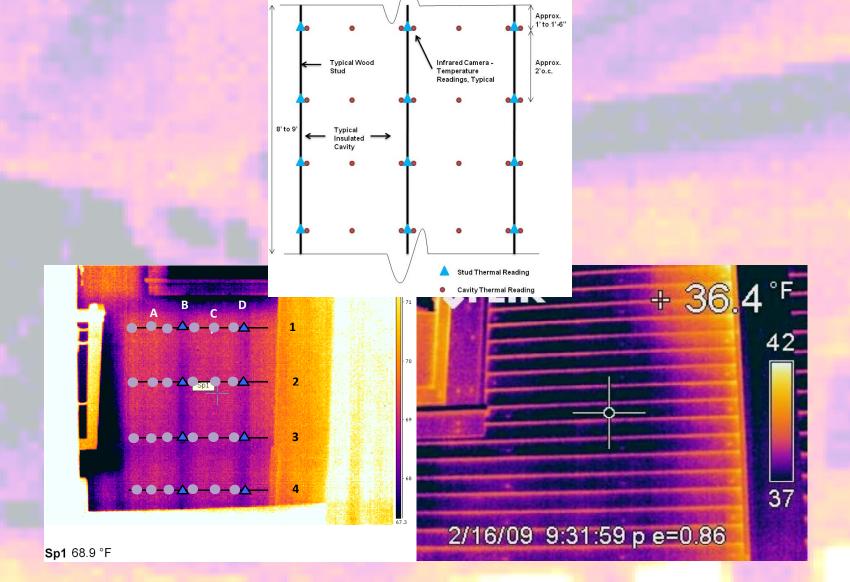
Cavity	Cavity	Cavity	<b>Framing</b>	Cavity	Cavity	Cavity	<b>Framing</b>
				Stud				Stud
	(Left)	(Center)	(Right)	<b>^</b>	(Left)	(Center)	(Right)	<b>^</b>
ROW#	A	A	A	В	C	C	C	D
1	67.1	67.4	67.1	66.6	67.4	67.5	67.4	66.9
2	67.1	67.4	67.2	66.3	67.1	67.4	67.4	67.1
3	67.0	67.1	66.9	66.3	66.4	67.2	67.2	66.7
4	67.1	67.2	67.2	66.3	67.0	67.2	67.3	66.5

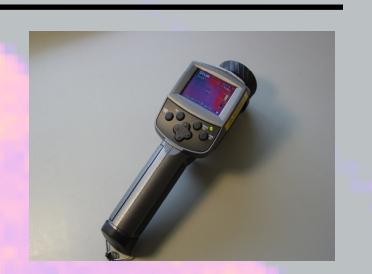
Step 6 – Use (ITC and NCI) Chart to Determine Actual R-Value

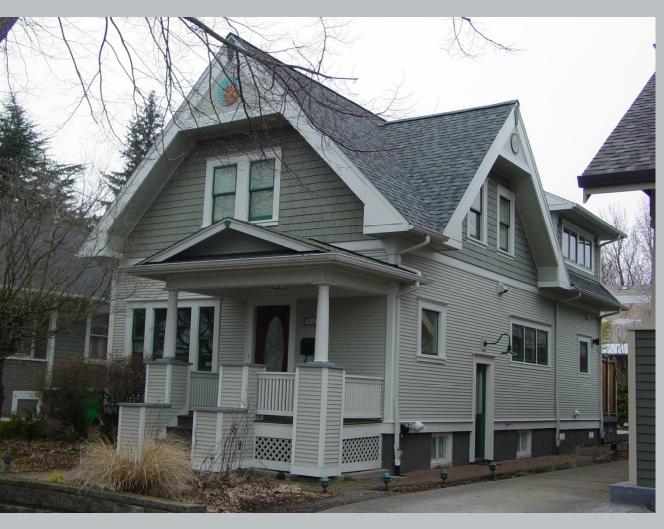
## WALL R-VALUE COMPARISON Predicted (Calculated) R-16 R-value Cavity Oregon 2003 Energy Code R-15 ■ R-value Stud Average R-value Cavity/Stud Wall-1 Wall-2 Wall-3 Wall-4 R-value Cavity 9.5 13.5 ASHRAE R-13 Standard R-value Stud 6.5 7.5 11 Average R-value Cavity/Stud 8.5 7.5 13

All four wall test areas were shown to be below the whole wall actual R-value when compared to the predicted (calculated) R-16 value and the 2003 Oregon Building Energy Code R-15 requirement. Only Wall-4 met the minimum R-13 ASHRAE insulation standard. The average whole wall R-value for all four walls was R-9.5.

- Predicted (calculated): R-16 compared to R-9.5 = 41%
- 2003 Oregon State Building Code: R-15 compared to R-9.5 = 37%
- ASHRAE Standard 90.1-2007: R-13 compared to R-9.5 = 27%

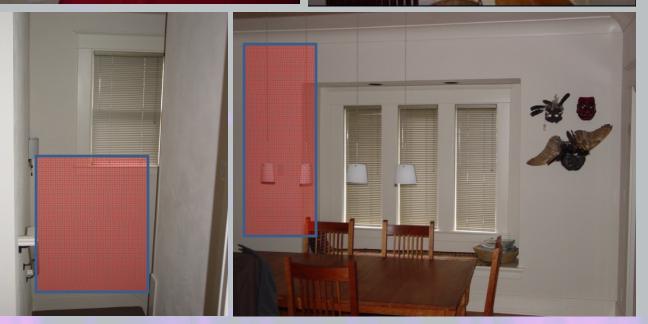
R-VALUE for 2X4 WALL at STUD AREAS					
Component	Thickness	R-Value			
Inside Air Film	-	0.68			
Interior Plaster	3/4"	0.45			
2x4 Nominal Stud Framing	4"	4.56			
Horizontal Sheathing Boards	3/4"	0.93			
Plywood Sheathing	1/2"	0.62			
60 Min. Building Paper	nil	0.06			
Cedar Drop-Lap Siding	1/2"	0.81			
Exterior Air Film	-	0.17			
TOTAL R-VALUE (STUD WALL AREA)		8.28

R-VALUE for 2X4 WALL at CAVITY AREAS (Cellulose)				
Component	Thickness	R-Value		
Inside Air Film	-	0.68		
Interior Plaster	3/4"	0.45		
Cellulose Insulation	4"	13.68		
Horizontal Sheathing Boards	3/4"	0.93		
Plywood Sheathing	1/2"	0.62		
60 Min. Building Paper	nil	0.06		
Cedar Drop-Lap Siding	1/2"	0.81		
Exterior Air Film	-	0.17		
TOTAL R-VALUE (CAVITY WALL AREA)		17.4
